Testing lags behind blade development

As rotor blades get longer and lighter, more complex designs introduce potential errors during manufacturing, while testing and certification are too limited in their nature. The result can be expensive failures and downtime. [Sara Knight](#) investigates

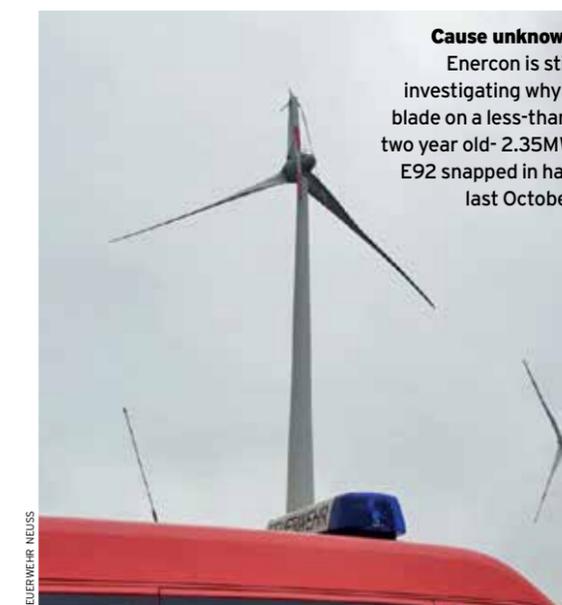
Cause unknown

Enercon is still investigating why a blade on a less-than-two year old- 2.35MW E92 snapped in half last October

Even turbines that have been operating for less than two years have suffered serious problems. In October 2018, for example, one of the blades mounted on a 2.35MW Enercon E92 turbine at the Neuss project in Germany snapped in half, just 16 months after commissioning. In mid-January, Enercon said the examination and analysis of the blade to explain the failure had not yet been completed.

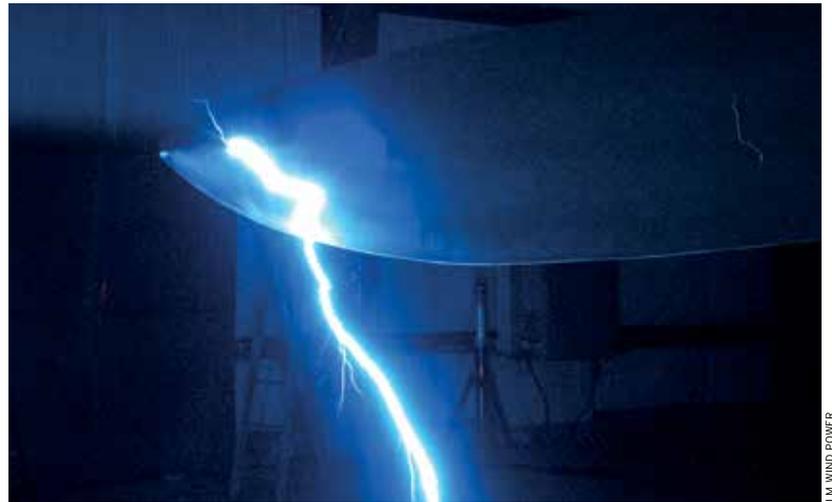
Striking Blades being tested to withstand lightning, the main cause of damage in Europe

Lightning damage affects old and new blades alike. The stability required for ever-longer blades is generally achieved by using more carbon fibre. Modern turbines often have tip heights exceeding 200 metres, which makes them more vulnerable. They often take hits, with the damage mainly occurring at the lightning receptors and the blade area around them.
